**Company Name:** Church Fields (Swindon) Management Company Limited

**Inspector Name:** Thomas Dellow AIRPM

**Inspection Date:** 09 February 2023

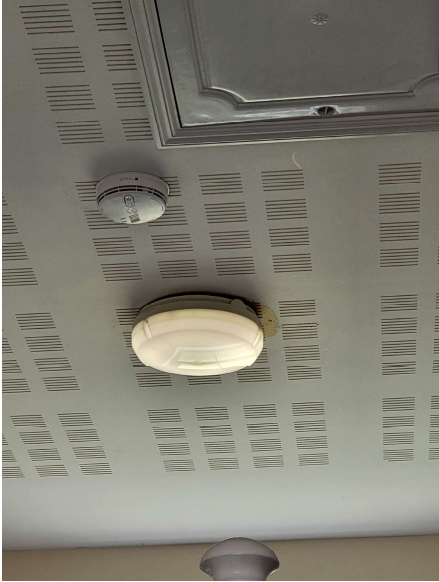
| Internal Inspection | Acceptable | Not Acceptable | N/A | Comments | Action |
|---|---|---|---|---|---|
| <b>Hallway</b><br>(Communal Lobbies and Stairs) | ✓ | | | The hallways appeared in good visual condition. | None |

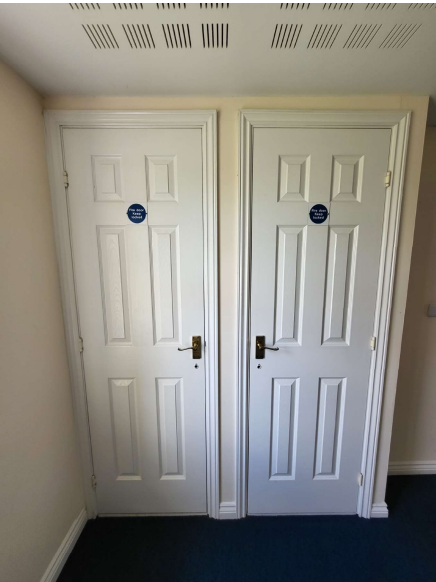
| Internal Inspection | Acceptable | Not Acceptable | N/A | Comments | Action |
|---|---|---|---|---|---|
| <b>Cupboard Doors</b><br>(Electrical Cupboard Doors) | | ✓ | | The electrical cupboards are not fitted with locks or smoke seals. Further inspection required. | Review |

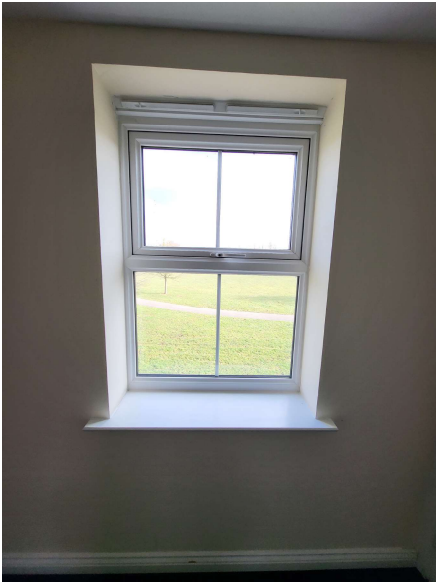
| Internal Inspection | Acceptable | Not Acceptable | N/A | Comments | Action |
|---|---|---|---|---|---|
| <b>Windows</b><br>(Communal Windows) | ✓ | | | The communal windows appeared in good visual condition. | None |

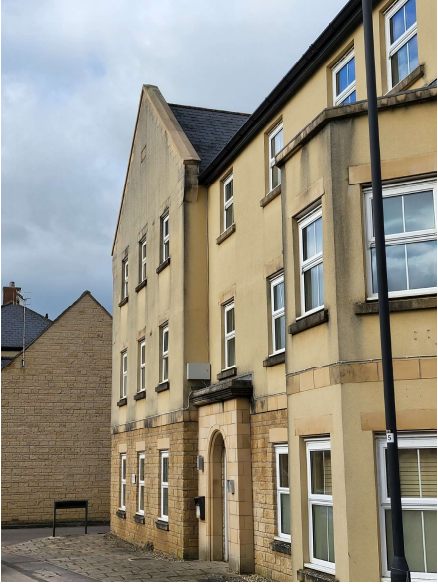
| External Inspection | Acceptable | Not Acceptable | N/A | Comments | Photos |
|---|---|---|---|---|---|
| Exterior Structure<br>(The Building) | ✓ | | | The exterior appeared in good visible condition. A soft washing of the rendered elements could be considered. | Review |

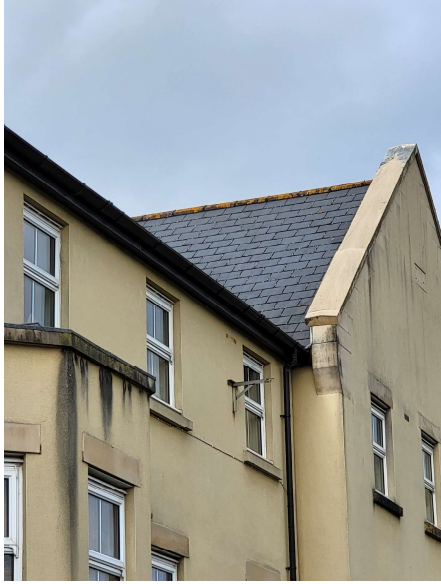
| External Inspection | Acceptable | Not Acceptable | N/A | Comments | Photos |
|---|---|---|---|---|---|
| Guttering<br>(Gutters and Fascia) | ✓ | | | The gutters appeared in good visible condition. | None |

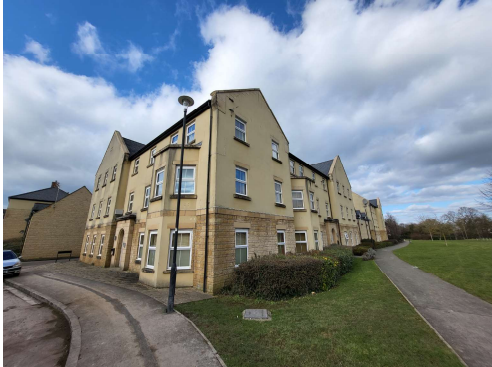
| External Inspection | Acceptable | Not Acceptable | N/A | Comments | Photos |
|---|---|---|---|---|---|
| Roofing<br>(Tiles and Cladding) | ✓ | | | The roof appeared in good visible condition. | None |

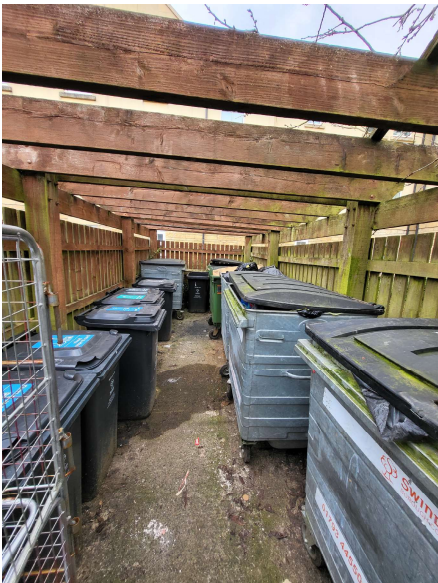
| External Inspection | Acceptable | Not Acceptable | N/A | Comments | Photos |
|---|---|---|---|---|---|
| Bin Store<br>(Waste Disposal Areas) | | ✓ | | Items were fly-tipped in the bin store but were not causing an obstruction. | Review |

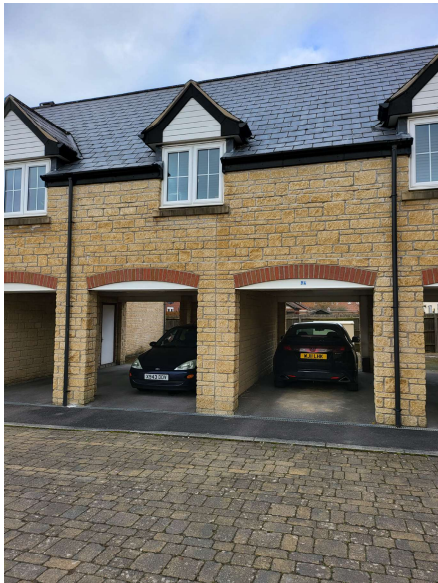
| External Inspection | Acceptable | Not Acceptable | N/A | Comments | Photos |
|---|---|---|---|---|---|
| Car Park<br>(Vehicle Parking) | ✓ | | | The car parking spaces were accessible. It was noted that the car ports on the left of the site were boarded and would be investigated on handover. | None |
