# COMBINED FIRE AND HEALTH & SAFETY RISK ASSESSMENT.

| Address of premises: | 60-70, 72-82 and 86-96 Cassini Drive,<br>Swindon,<br>SN25 2JY |
| Date of fire risk assessment: | 4 <sup>th</sup> March 2025 |

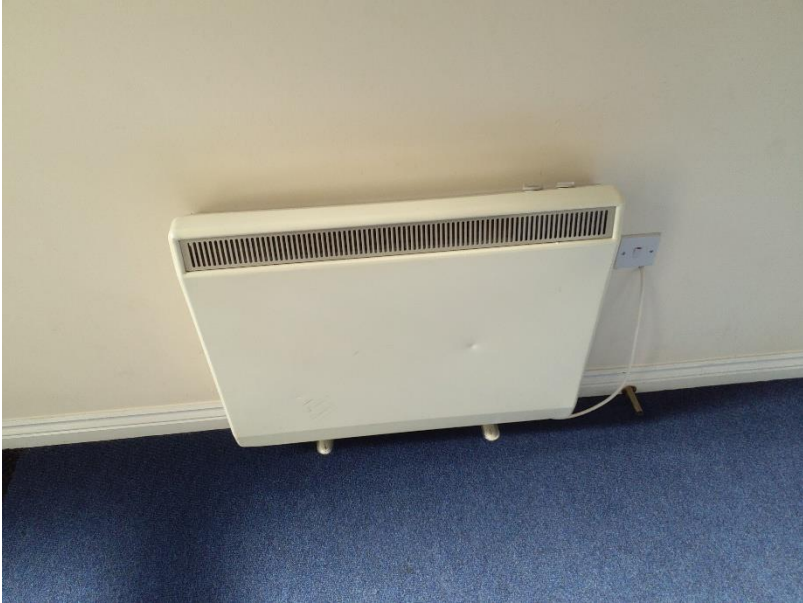
| 03 | <p>The communal areas are heated by wall mounted electrical heaters, it is recommended that these be inspected and tested by a competent person in line with the fixed electrical installation.</p> | 3 | C | <p>Action required</p> <p>Heaters are no longer in use and are switched off. Scheduled to remove units during redecorations</p> |

| The communal areas are heated by wall mounted electrical heaters, it is recommended that these be inspected and tested by a competent person in line with the fixed electrical installation. | | |

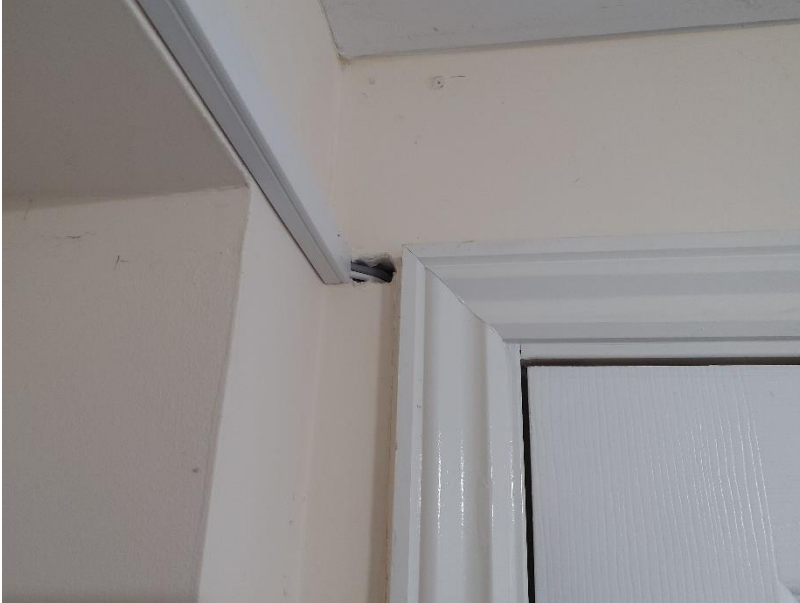
| 08 | <p>It was noted during this fire risk assessment that there was a small breach in the ground floor communal area communicating with the top of the electrical intake cupboard. This could allow smoke and fire to pass into the communal area from the electrical intake cupboard in the event of a fire. It is therefore recommended that the RP instructs a suitably qualified and competent contractor to repair the breach with a suitable compound capable of providing a minimum of 30 minutes fire resistance.</p> | 2 | B | Action required<br>Contractor instructed to effect repairs |

| It was noted during this fire risk assessment that there was a small breach in the ground floor communal area communicating with the top of the electrical intake cupboard. This could allow smoke and fire to pass into the communal area from the electrical intake cupboard in the event of a fire. It is therefore recommended that the RP instructs a suitably qualified and competent contractor to repair the breach with a suitable compound capable of providing a minimum of 30 minutes fire resistance. | | |

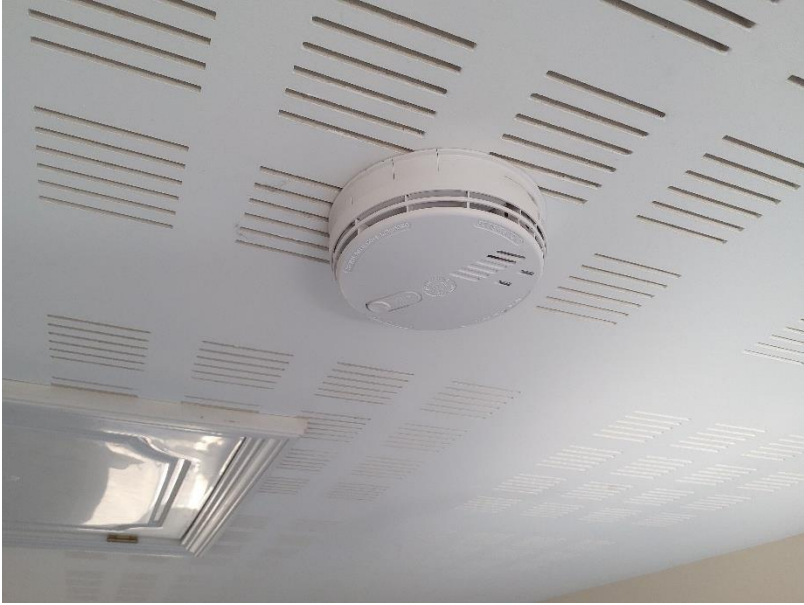
| 09 | <p>It was noted during this fire risk assessment that battery powered smoke detectors were installed within each block. This could be considered as an overprovision for this purpose-built block of flats implementing a stay put evacuation policy. Consideration could be given by the RP as to their removal. This is in line with current fire safety guidance for purpose-built flats.</p> | 3 | B | <p>Action required</p> <p>Contractor instructed to remove detectors as per current advice</p> |

| <p>It was noted during this fire risk assessment that battery powered smoke detectors were installed within each block. This could be considered as an overprovision for this purpose-built block of flats implementing a stay put evacuation policy. Consideration could be given by the RP as to their removal. This is in line with current fire safety guidance for purpose-built flats.</p> <p>Each flat is responsible for their own fire precautions and it is recommended that the RP advise each resident of the importance of installing smoke detectors within their flat. One battery operated smoke detector in the lobby of each flat would be the minimum provision, however mains powered smoke detectors, each with a battery backup, installed within the escape route of each flat, in all rooms that communicate with the escape route and a heat detector within the kitchen, interlinked to form a BS5839-6: 2019 Grade D detection system with LD2 coverage would be the preferred and safest option for each occupant.</p> | | |
