# COMBINED FIRE AND HEALTH & SAFETY RISK ASSESSMENT.

Address of premises:	60-70, 72-82 and 86-96 Cassini Drive, Swindon, SN25 2JY
Responsible Person:	Church Fields (Swindon) Management Company Limited
Duty Holder:	Block Management Limited
Person(s) consulted:	No occupier or other relevant person available to consult.
Assessor:	Rob Cockburn
Report validated by:	John Godfrey, GIFireE.
Date of fire risk assessment:	4 <sup>th</sup> March 2025/ Reviewed June 2026
Date of previous fire risk assessment:	15 <sup>th</sup> March 2023
Suggested date for review:	March 2027

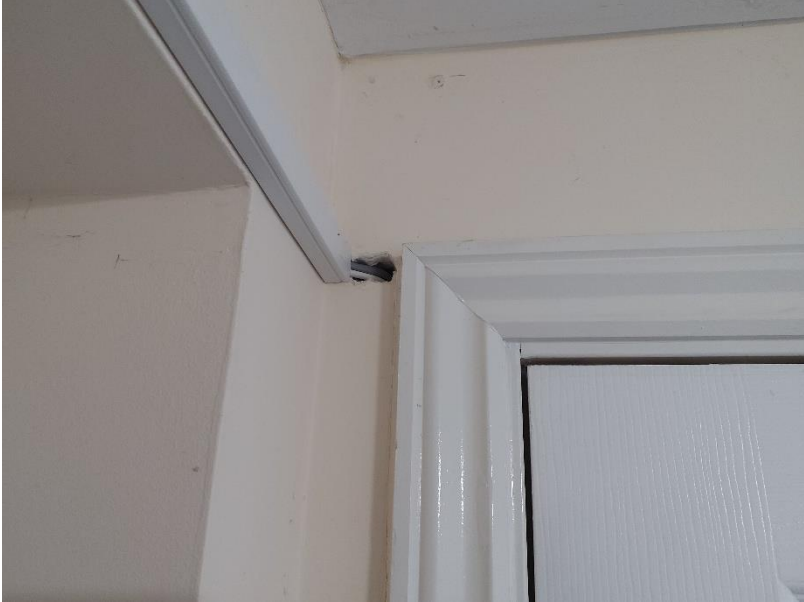
07	There were no disabled occupants identified during this assessment. In the event of a disabled person requiring access to the premises (i.e. an employee, a visitor or a contractor) a Personal Emergency Evacuation Plan (PEEP) should be written and implemented by the RP.	3	C	Ongoing action DH action as required
08	<p>It was noted during this fire risk assessment that there was a small breach in the ground floor communal area communicating with the top of the electrical intake cupboard. This could allow smoke and fire to pass into the communal area from the electrical intake cupboard in the event of a fire. It is therefore recommended that the RP instructs a suitably qualified and competent contractor to repair the breach with a suitable compound capable of providing a minimum of 30 minutes fire resistance.</p>

2	B	Action complete Contractor has attended to repair minor breaches.

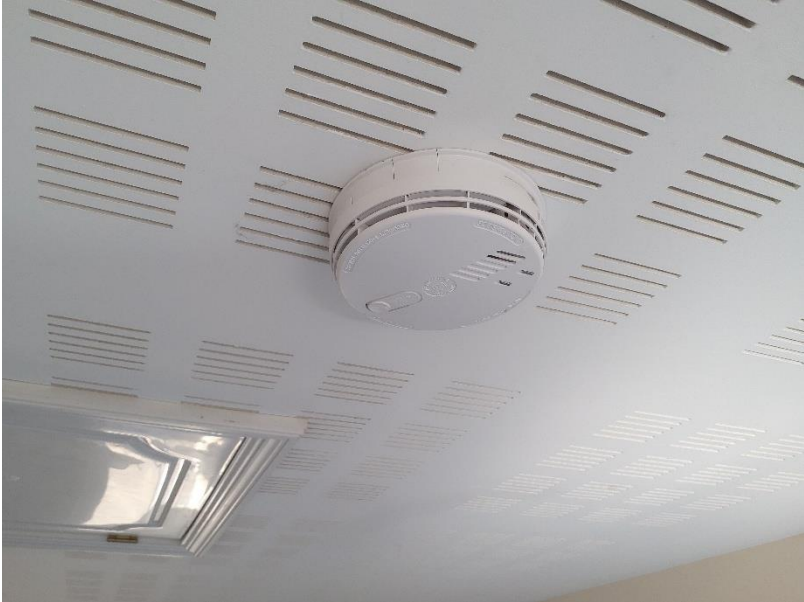
<p>09</p>	<p>It was noted during this fire risk assessment that battery powered smoke detectors were installed within each block. This could be considered as an overprovision for this purpose-built block of flats implementing a stay put evacuation policy. Consideration could be given by the RP as to their removal. This is in line with current fire safety guidance for purpose-built flats.</p>

<p>3</p>	<p>B</p>	<p>Action required Contractor instructed to remove detectors as per current advice</p>
<p>10</p>	<p>Each flat is responsible for their own fire precautions and it is recommended that the RP advise each resident of the importance of installing smoke detectors within their flat. One battery operated smoke detector in the lobby of each flat would be the minimum provision, however mains powered smoke detectors, each with a battery backup, installed within the escape route of each flat, in all rooms that communicate with the escape route and a heat detector within the kitchen, interlinked to form a BS5839-6: 2019 Grade D detection system with LD2 coverage would be the preferred and safest option for each occupant.</p>	<p>3</p>	<p>C</p>	<p>Ongoing action required DH provide this information annually and via website</p>
